1 INTRODUCTION

Yakima Air Terminal/McAllister Field (YKM) is a commercial service airport located in the city and county of Yakima, Washington, approximately five miles south of downtown Yakima. The airport service area consists of portions of Yakima, Lewis, King, and Kittitas Counties—a population of approximately 270,700 people according to an air service study conducted for the Airport Board in 2005. The present passenger terminal building was developed in three major projects. The original building was constructed in 1950 at a cost of \$200,000. In 1968, the Airport added ground level concourses in a “V” configuration to provide an enclosed circulation space for passengers closer to the aircraft parking positions. The terminal was expanded and renovated further between 1997 and 2000, expanding the airside passenger hold room, adding toilets to the secure area, and installing a canopy over the baggage unloading area. On the landside, the project reconstructed the departures/arrivals curbside canopy and renovated the passenger ticketing and baggage claim lobbies.

A URS team conducted the Facility Assessment in June and July of 2011. The team included a terminal planner and arch

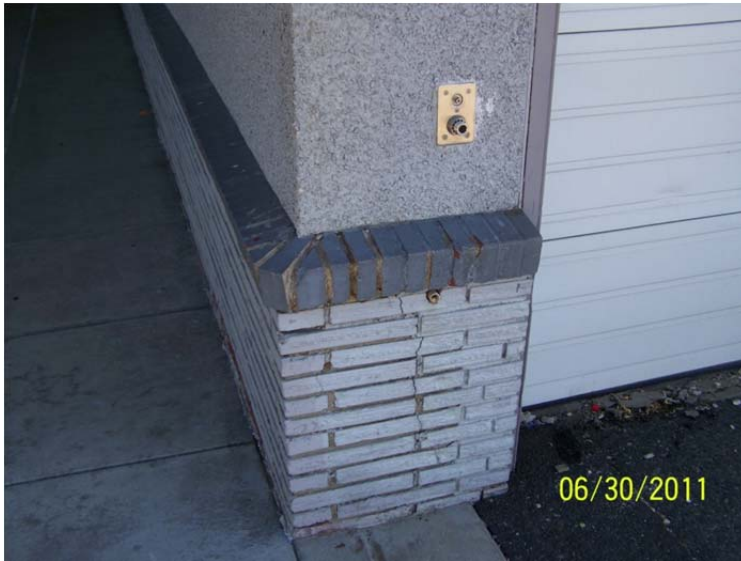
S-1: Cracked and deteriorated mortar joints in exterior brick veneer

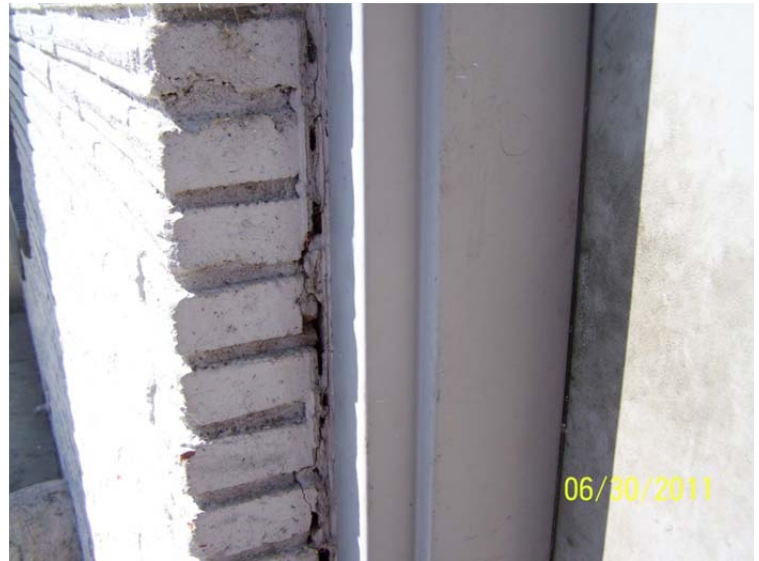
S-2: Deteriorated caulking at exterior face brick veneer

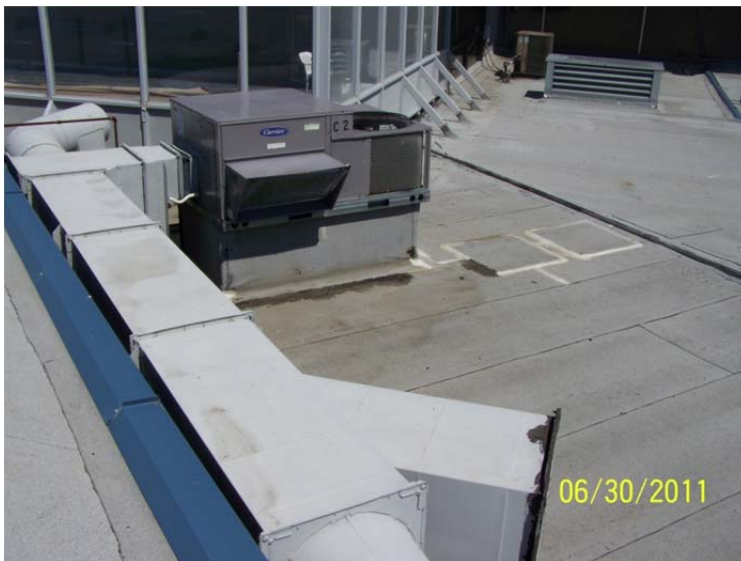
The roofing system is a built-up granulated cap sheet that appears to have been installed on all of the buildings and canopies as part of the 1997–2000 rehabilitation projects, with the exception of the roof at the old control tower. Roofing appears to be in good condition with only one indication of standing water. Some standing water appears to occur to the southeast of the restaurant roof deck as indicated by staining (picture S-3). Maintenance personnel indicated there had been some water

intrusion in this area. Roofing under the roof deck could not be inspected. It appears the roof deck framing was laid directly on roofing. The condition of this roofing should be inspected further.

S-3: Evidence of ponding at roof

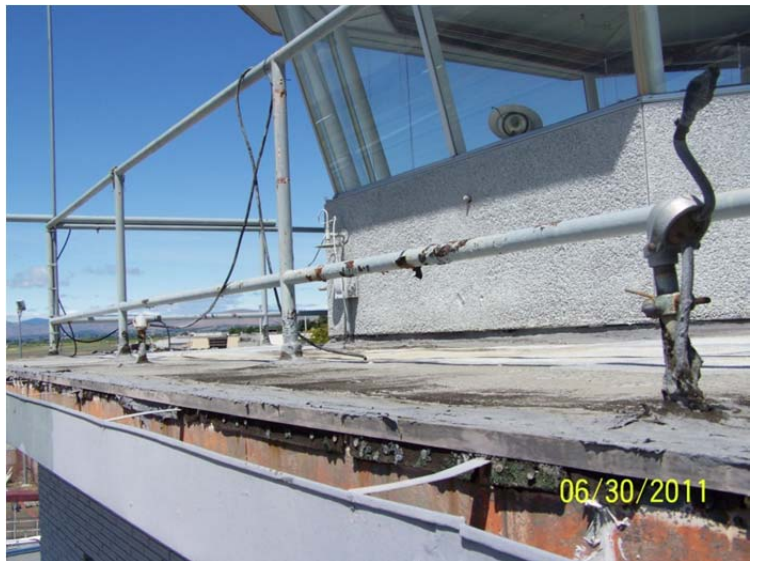
The roof system at the control tower does not appear to have been replaced during the rehabilitation and is deteriorated and in need of maintenance (picture S-4).

S-4: Roofing system and flashing in need of repair at low roof at former airport traffic control tower

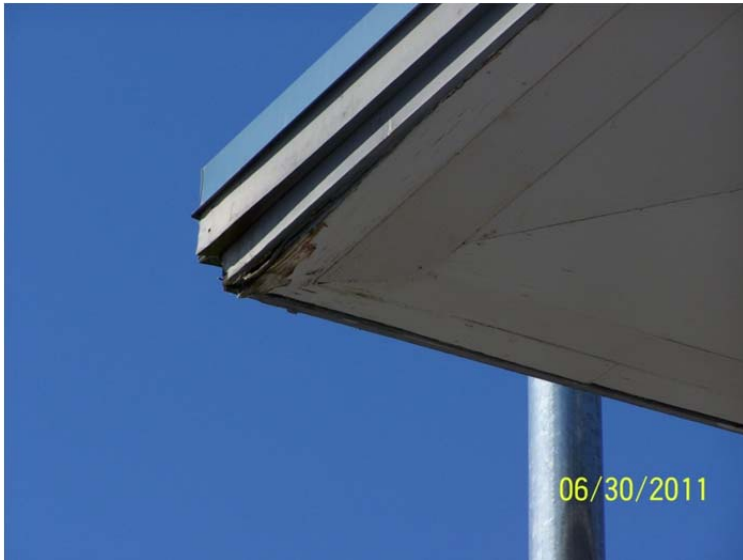
Exposed fascia board, soffits, and exposed roof beams at overhangs show minor water damage (pictures S-5 and S-6).

S-5: Water damage in fascia and overhanging soffit

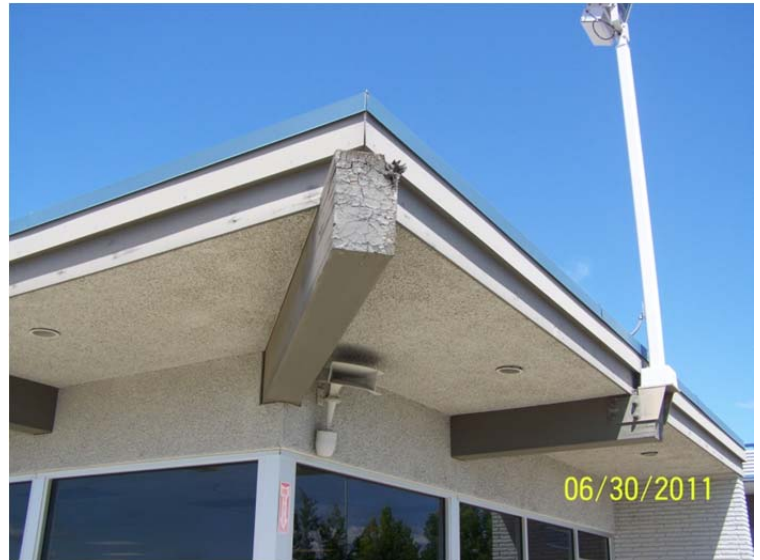
S-6: Water damage at end of exposed roof beam

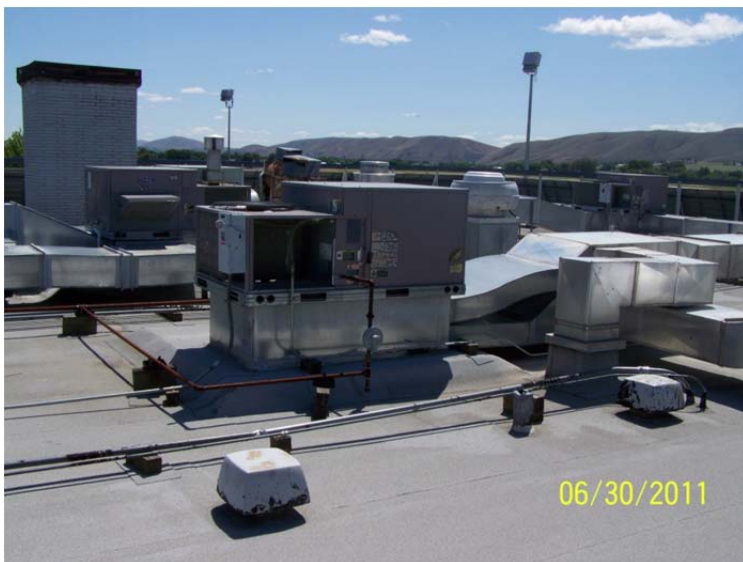
Rooftop mechanical systems appear to be properly seismically anchored. There are many rooftop mechanical units, ducting, piping, and roof screens with roof penetrations. The roofing at the penetrations should be inspected regularly for deterioration (pictures S-7 and S-8).

S-7: Roof top mechanical equipment

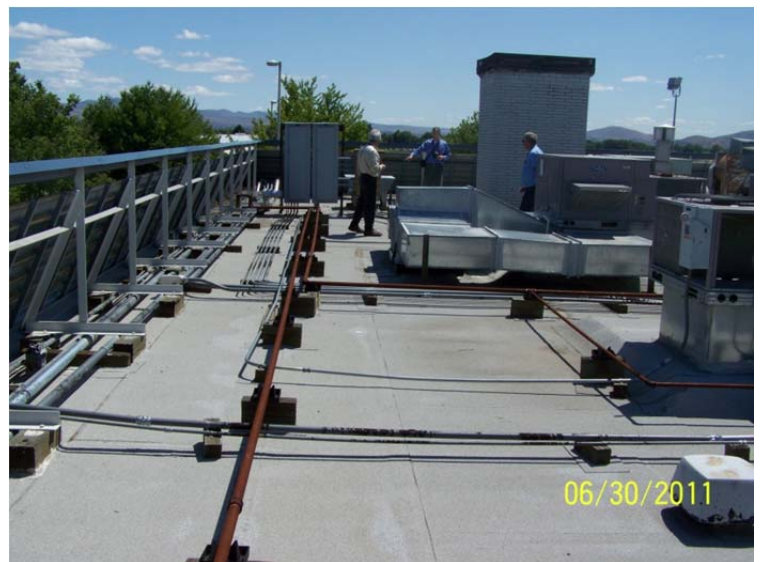
S-8: Roof top mechanical equipment

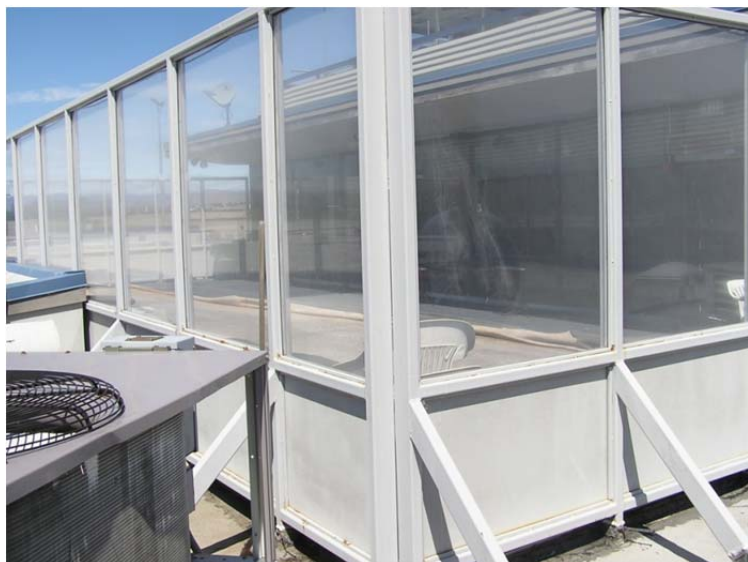
While the present roof condition is good, future risks for leaks abound because of the multiple roof levels, the exterior deck framing sitting directly on the built-up roof near the restaurant lounge (picture A-17), and the many roof penetrations by mechanical equipment, ductwork, power/communications conduits, and roof top equipment visual screens and bracing (picture A-20). Each of these, and there are many, represent a potential source of failure at a future date, and will be difficult to track down.

A-17: Exterior deck adjacent lounge

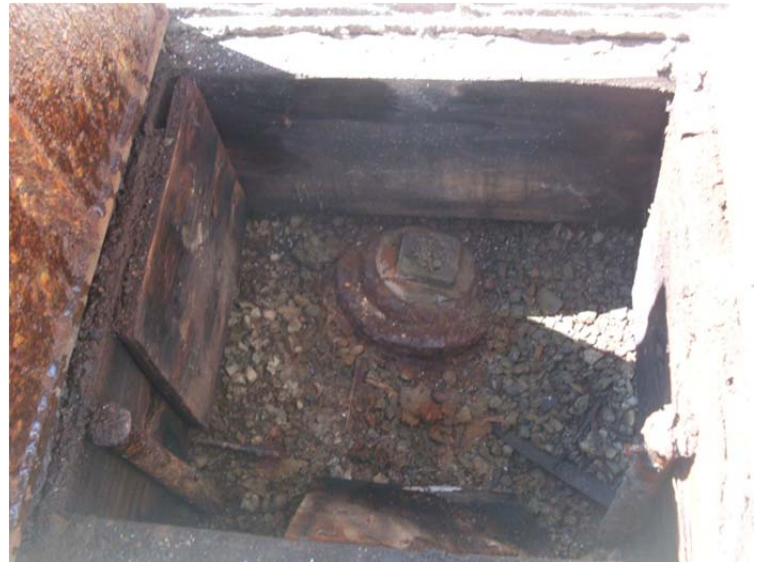
The drainage is connected to the single 10-inch storm sewer on the east (original) side of the building that serves the building and parking lot. Various catch basins and area drains are connected to the system (picture M-1). The system appears to provide adequate drainage except where pavement cracks or settling has occurred. The system reportedly has occasional clogs and better cleanout provisions are desired (picture M-6).

M-6: Parking drainage cleanout

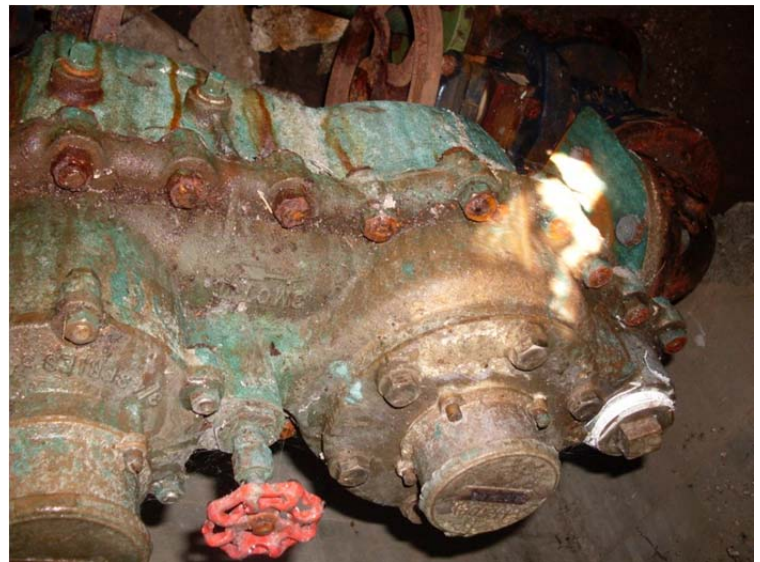
A 3-inch domestic water service line provides service to the terminal. It enters the building in the basement northeast mechanical room. The service is in good condition and the section from the existing underground water meter in the parking lot to the building appears to have been installed in approximately 2001. The water meter appears to be in poor condition (picture M-8) and is due for replacement by the water purveyor.

M-8: Building water meter

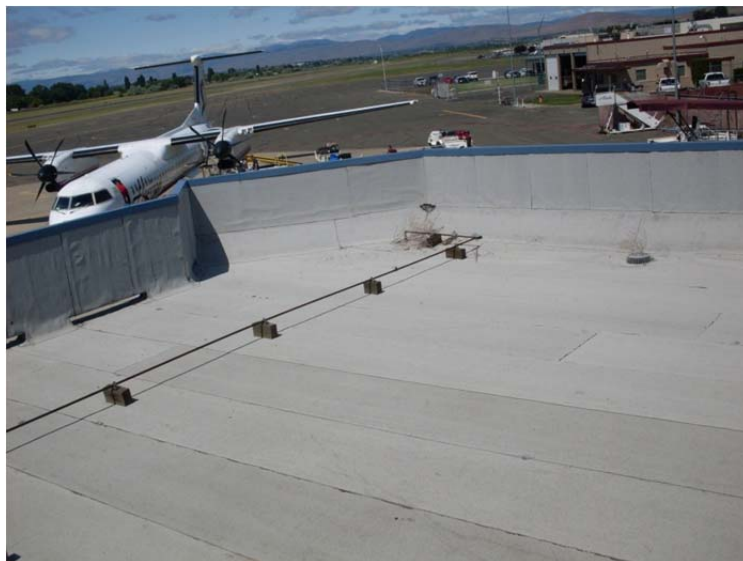
M-14: Rusty milled steel rooftop gas piping

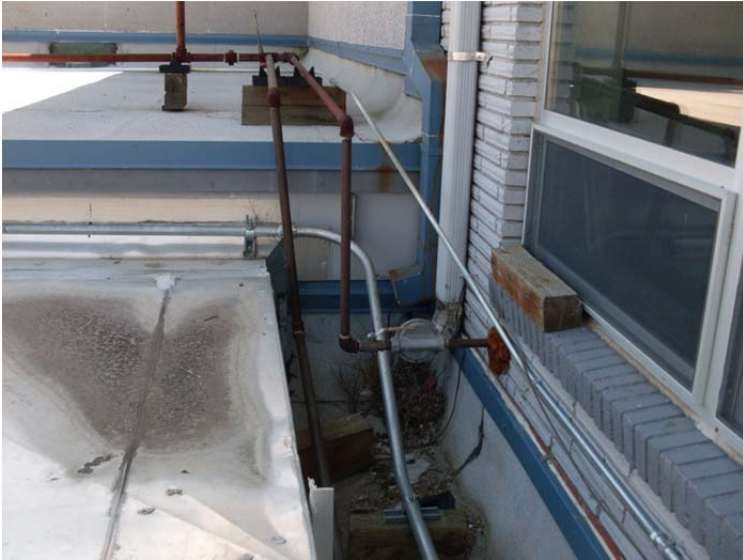
M-17: Rusty mild steel rooftop gas piping

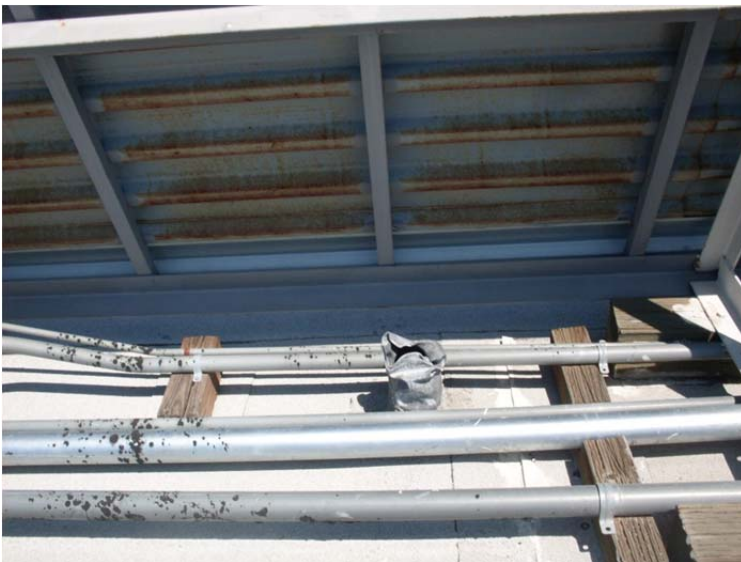
*M-24: Failing support blocks –crushed vent flashing

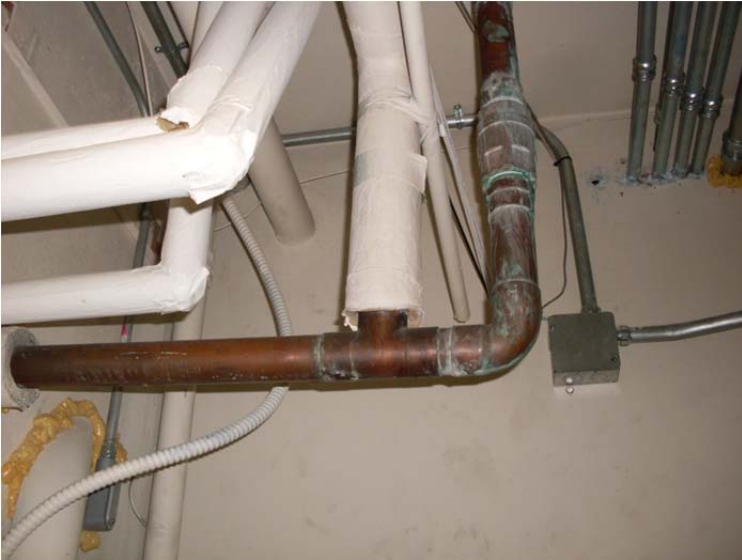
M-34: Missing domestic water pipe insulation

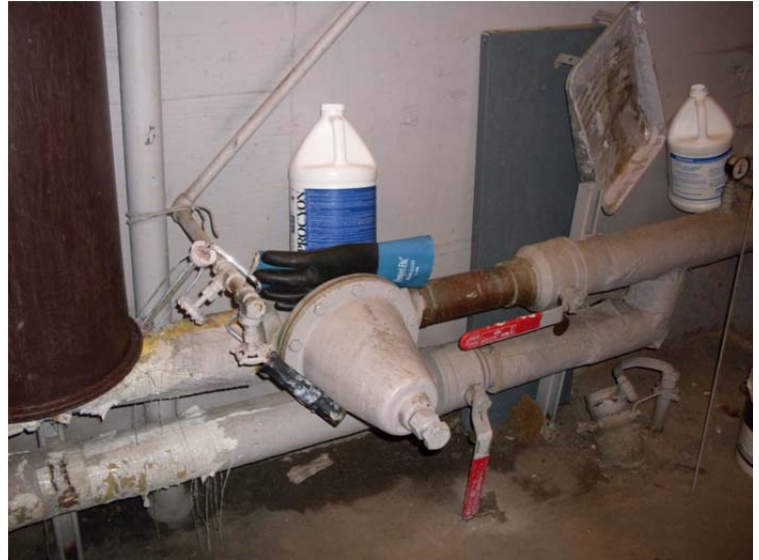
M-43: Main domestic water regulator without relief

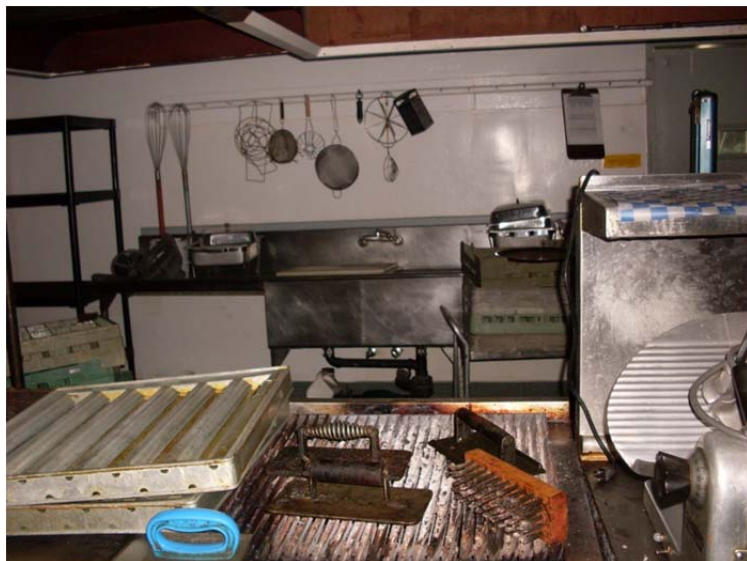
M-46: Kitchen plumbing fixture in poor condition

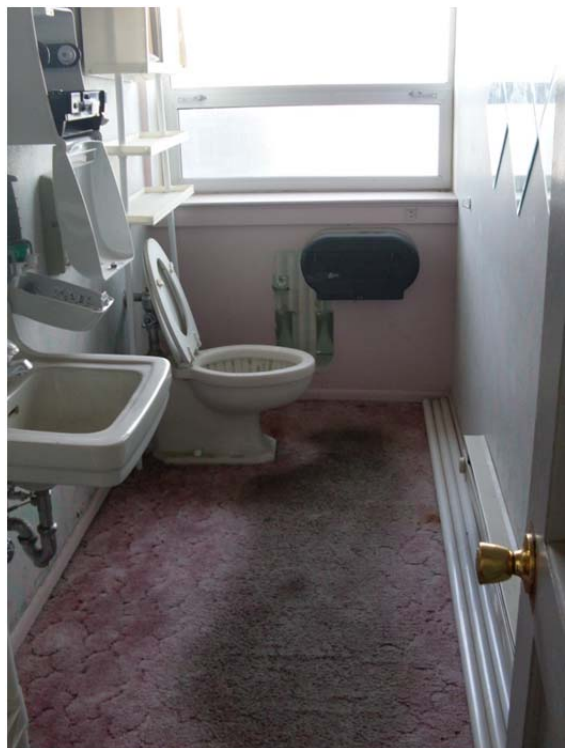
M-48: Plumbing fixtures in fair condition

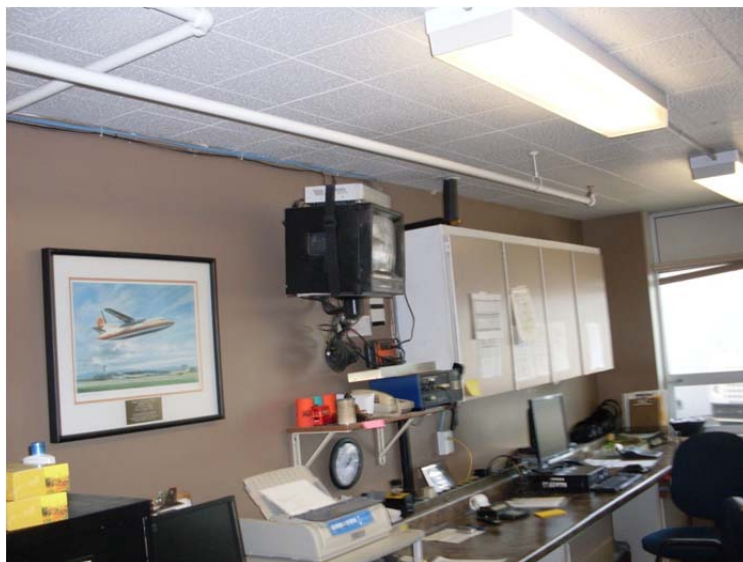
M-49: Exposed fire sprinklers below ceiling

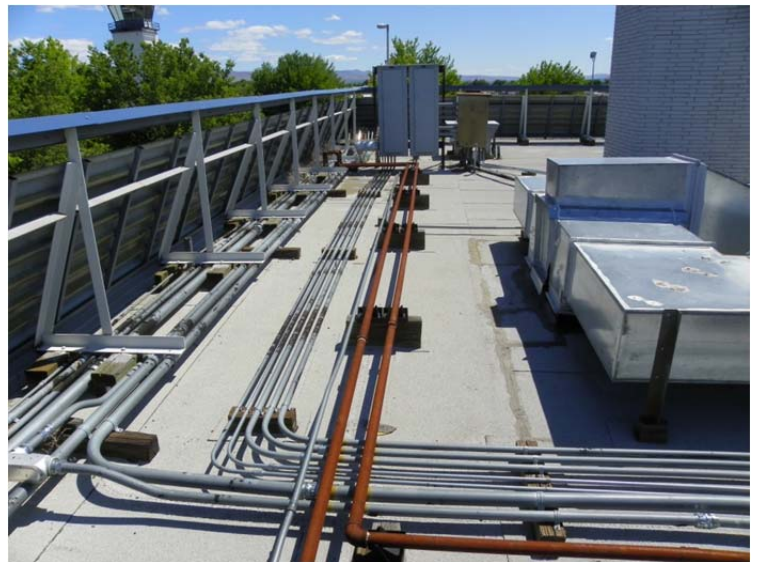
E-8: Roof panels and conduit routing
