1 INTRODUCTION

Yakima Air Terminal/McAllister Field (YKM) is a commercial service airport located in the city and county of Yakima, Washington, approximately five miles south of downtown Yakima. The airport service area consists of portions of Yakima, Lewis, King, and Kittitas Counties—a population of approximately 270,700 people according to an air service study conducted for the Airport Board in 2005. The present passenger terminal building was developed in three major projects. The original building was constructed in 1950 at a cost of \$200,000. In 1968, the Airport added ground level concourses in a “V” configuration to provide an enclosed circulation space for passengers closer to the aircraft parking positions. The terminal was expanded and renovated further between 1997 and 2000, expanding the airside passenger hold room, adding toilets to the secure area, and installing a canopy over the baggage unloading area. On the landside, the project reconstructed the departures/arrivals curbside canopy and renovated the passenger ticketing and baggage claim lobbies.

A URS team conducted the Facility Assessment in June and July of 2011. The team included a terminal planner and arch

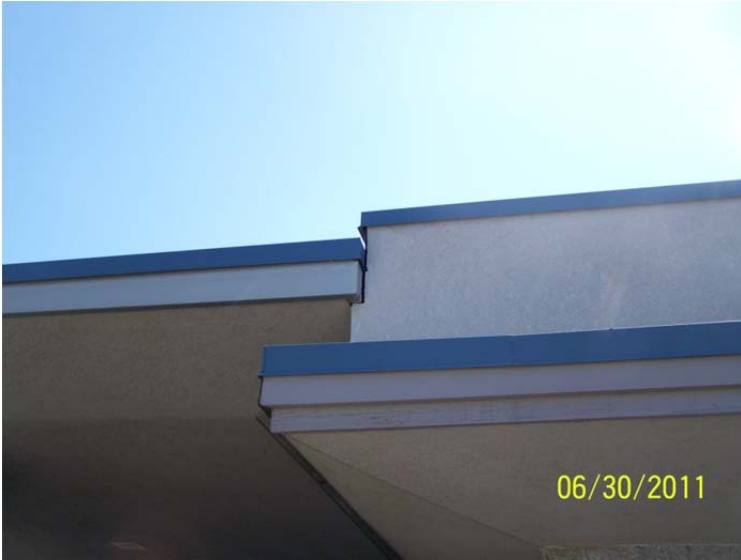
At the northwest canopy it appears that proper seismic separation was not provided between the canopy and the top of the building wall. The stucco should be repaired to prevent water intrusion (picture S-9).

S-9: Separation in overhang roof at building parapet

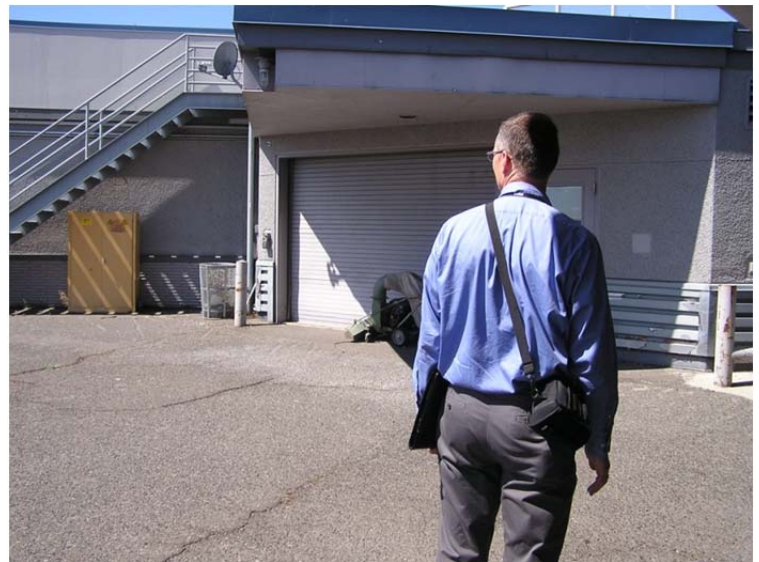
A-8: Outbound baggage makeup access (inactive)

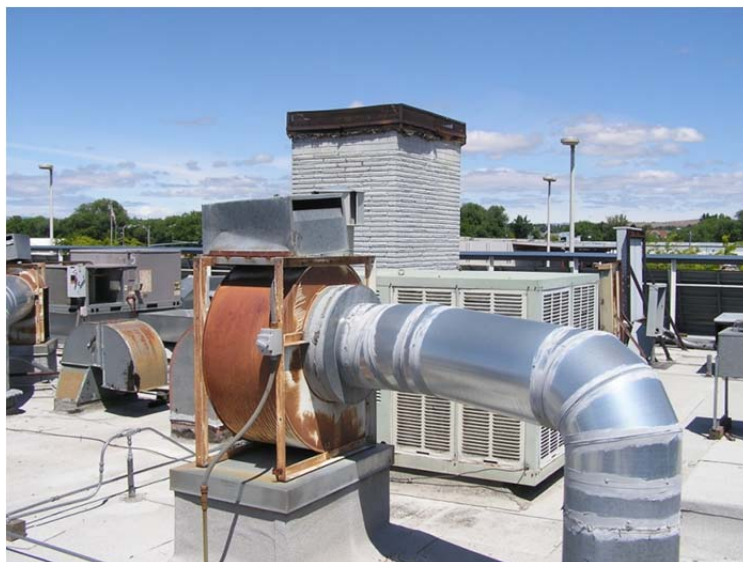
A-20: Roof-mounted mechanical equipment of various
vintages

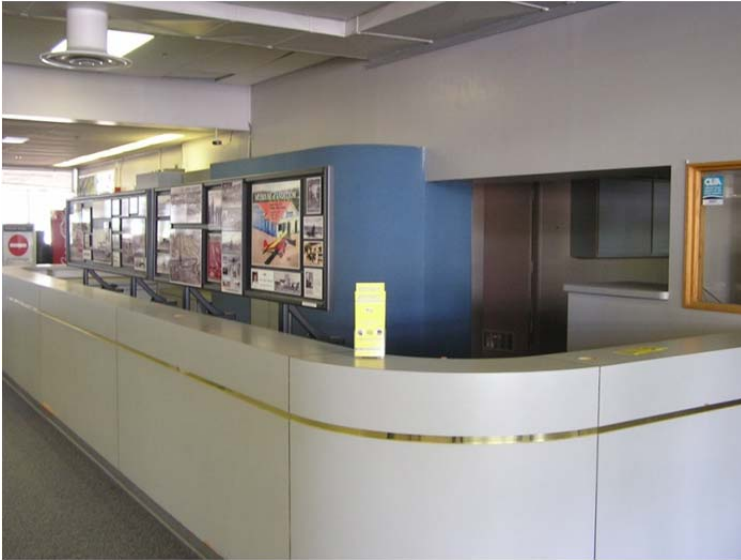
A-25: Travel agency counter and offices (inactive)

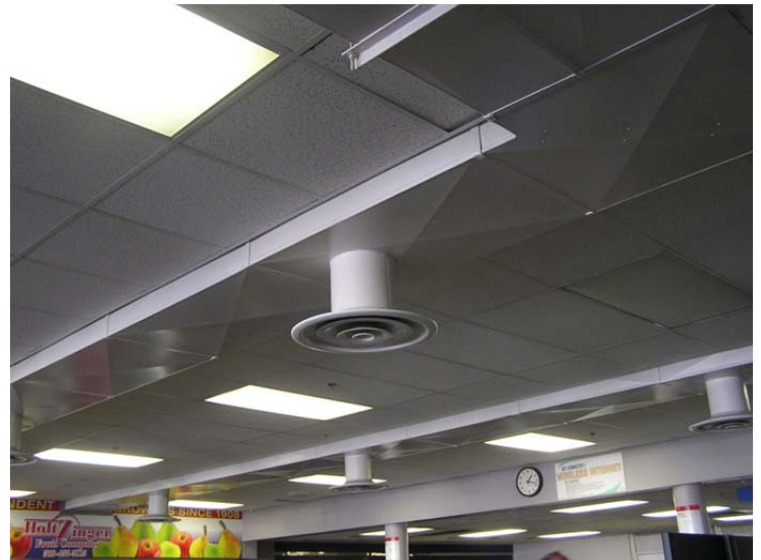
A-29: Exposed ductwork in ticket lobby ceiling

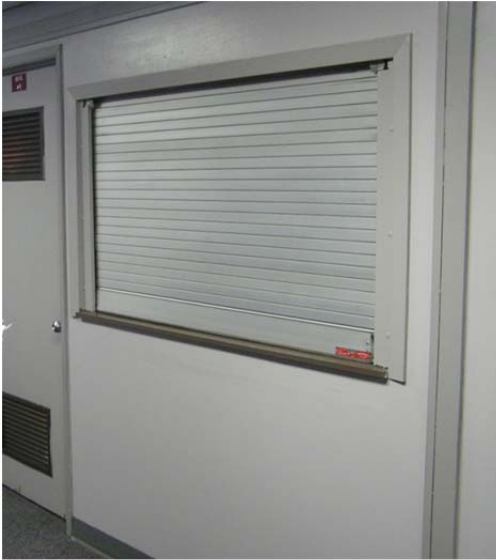
A-30: Food/drink concession (inactive)

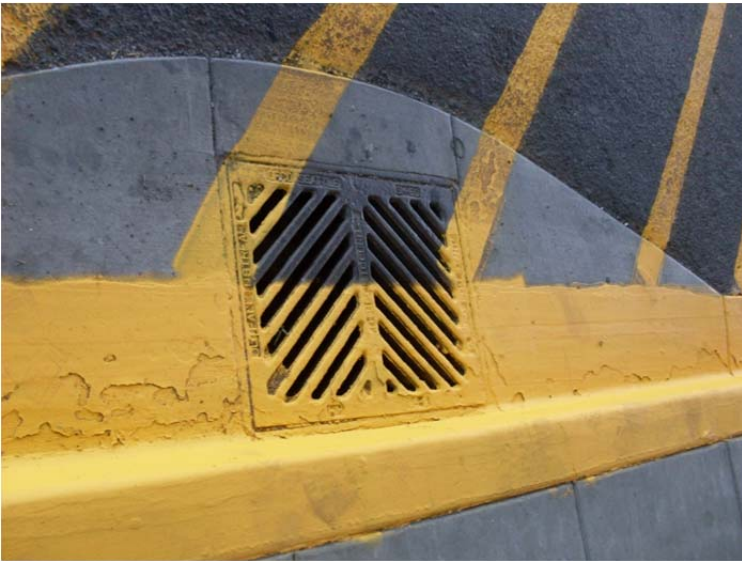
M-1: Storm drain catch basin at entry drive

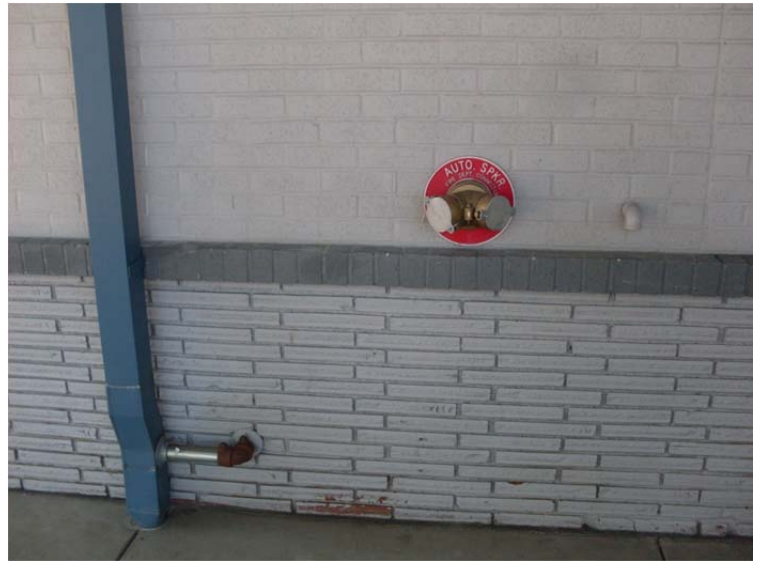
M-2: Fire Department siamese pumper hose connection

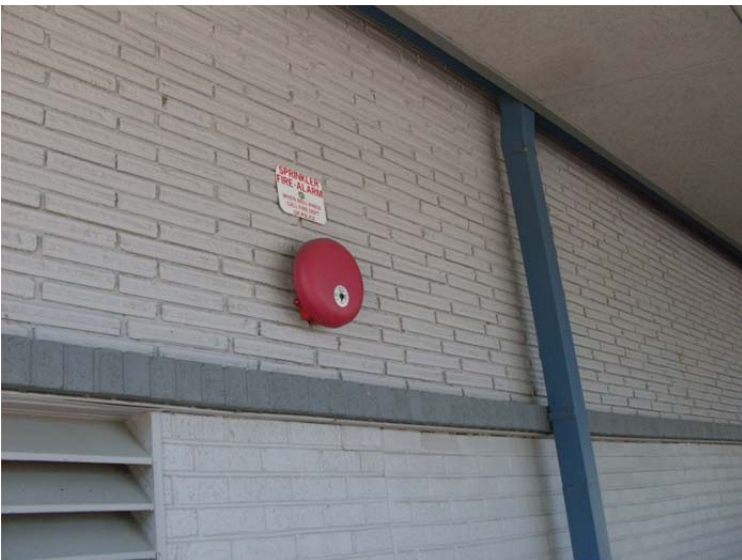
The fire protection service entrance includes a 6-inch main (picture M-41) (105 psi) (picture M-42) in fair condition with a newer approximately 3-inch backflow preventer assembly that connects to the building distribution system (picture M-39). A 4-inch Siamese pumper connection (FDC) (picture M-2) is located on the face of the building about 75 feet from the nearest fire hydrant. An alarm gong (picture M-3) is located above the FDC.

M-3: Electric fire alarm gong at front drive

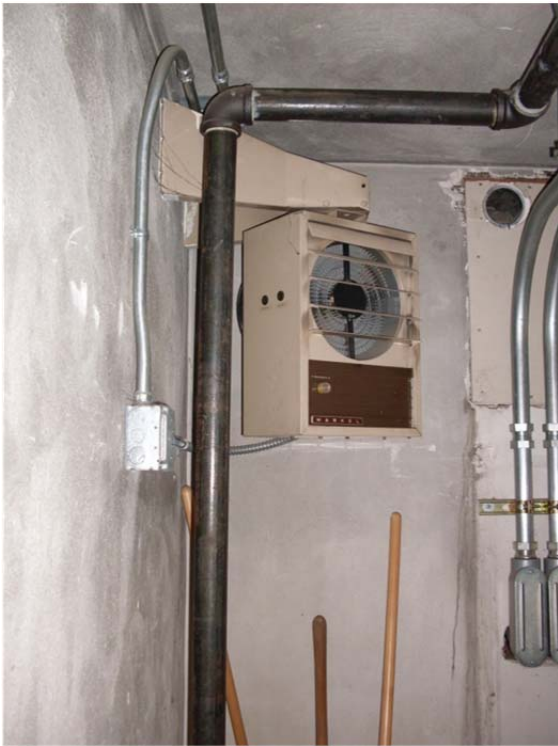
M-5: Typical electric heater

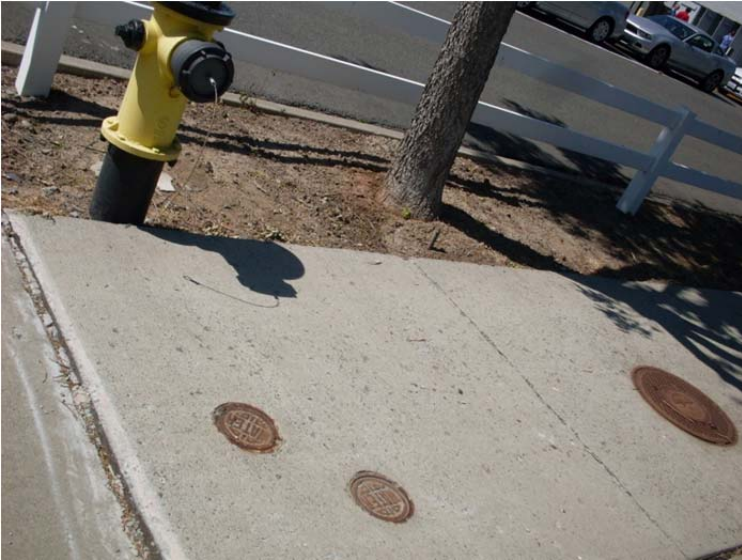
M-9: Fire hydrant at entry drive

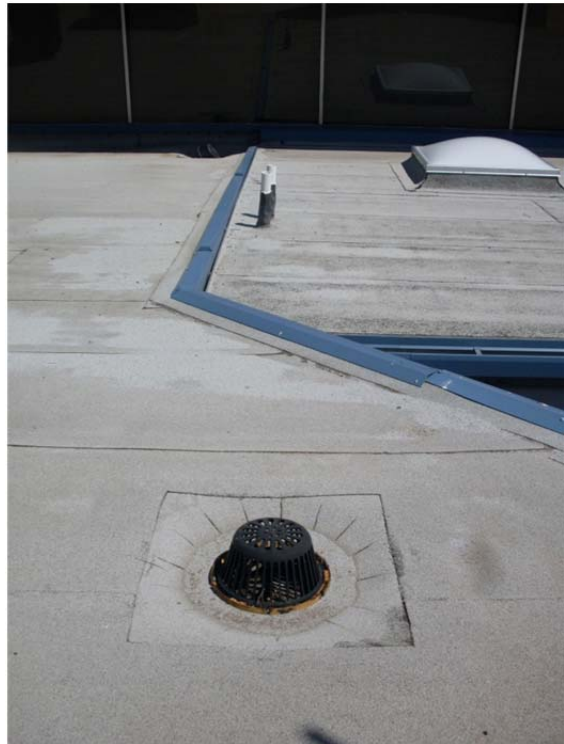
Flat roofs drain via cast iron roof drains with cast iron grates (picture M-10). All roofs appear to overflow to lower roofs or over the lip of the roof such that most roofs do not require overflow drains. Roof drain piping is mostly cast iron in fair to good condition with some galvanized noted on smaller roofs in poor condition.

M-10: Typical roof drain

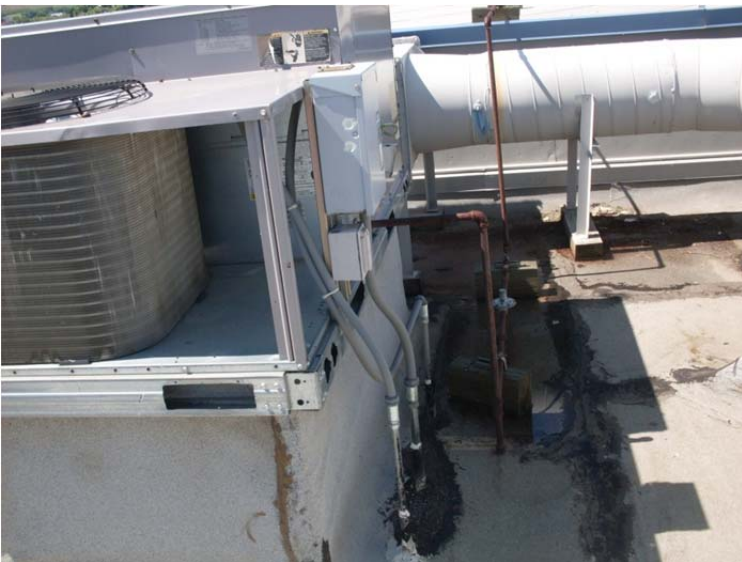
M-11: Split cooling unit condenser

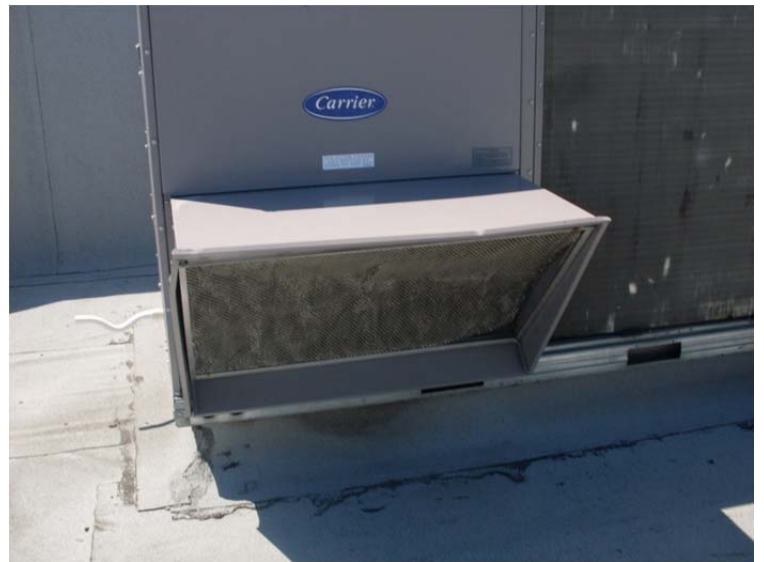
M-12: Gravity relief integral to rooftop unit

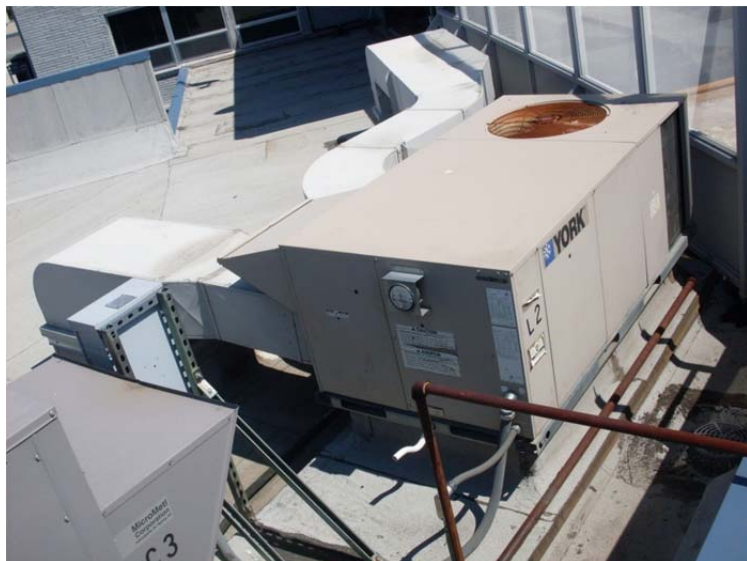
M-13: Typical rooftop ductwork

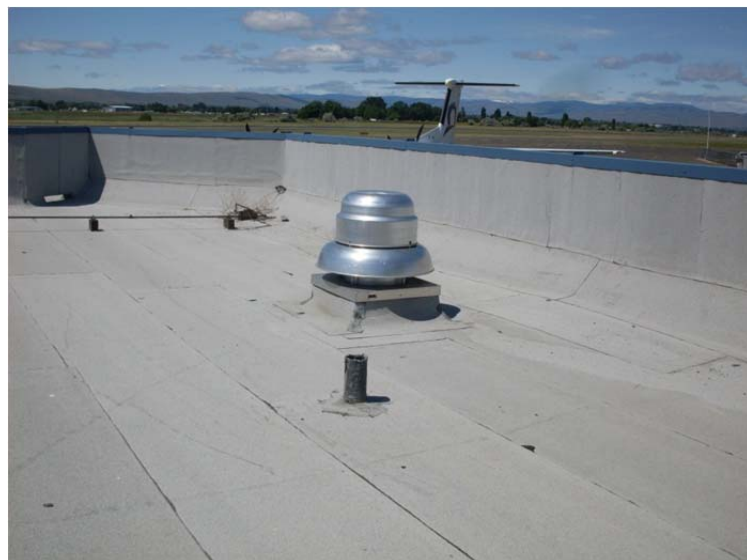
M-15: Aluminum mushroom roof exhaust fan

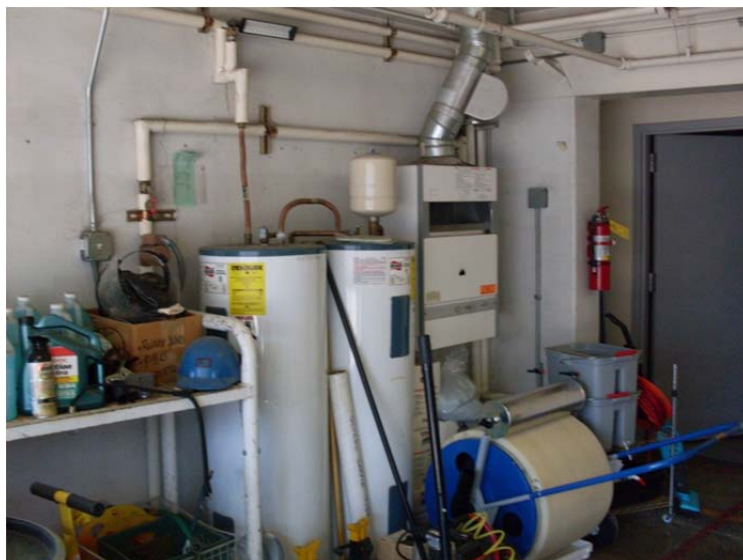
M-16: 80% efficient instantaneous gas water heater

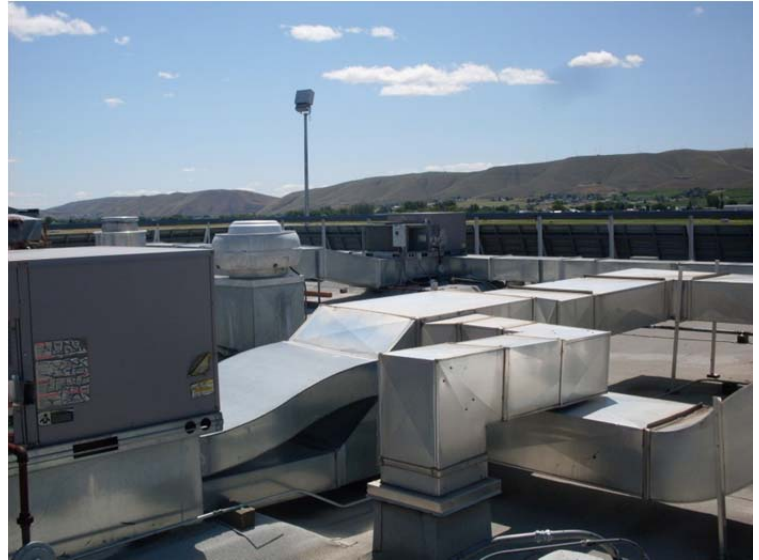
M-18: Typical galvanized steel rooftop ductwork

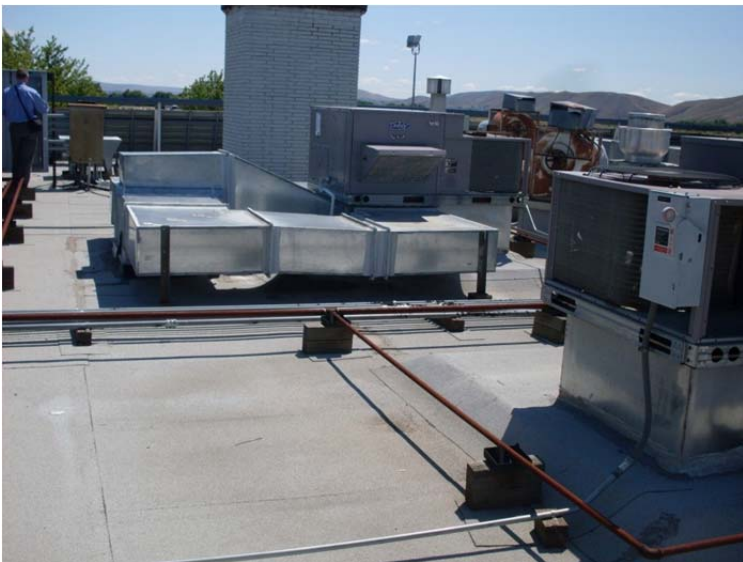
M-19: Galvanized steel rooftop ductwork

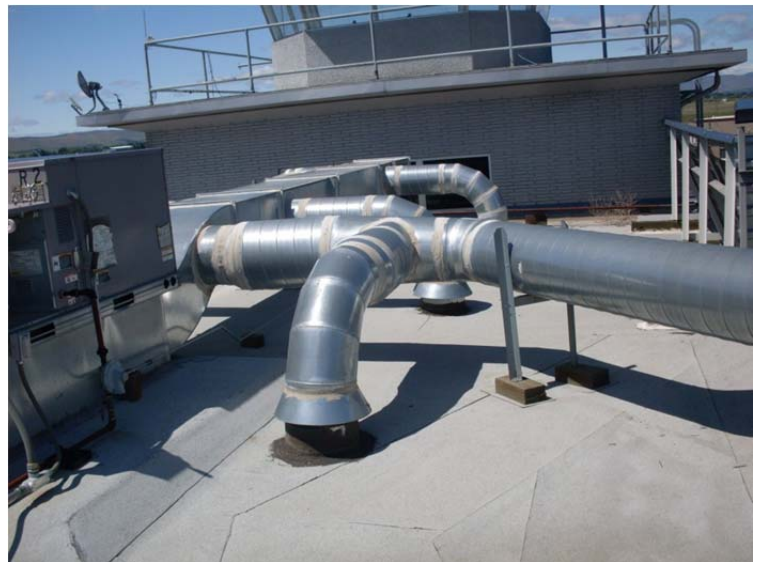
M-20: Double wall galvanized rooftop ductwork

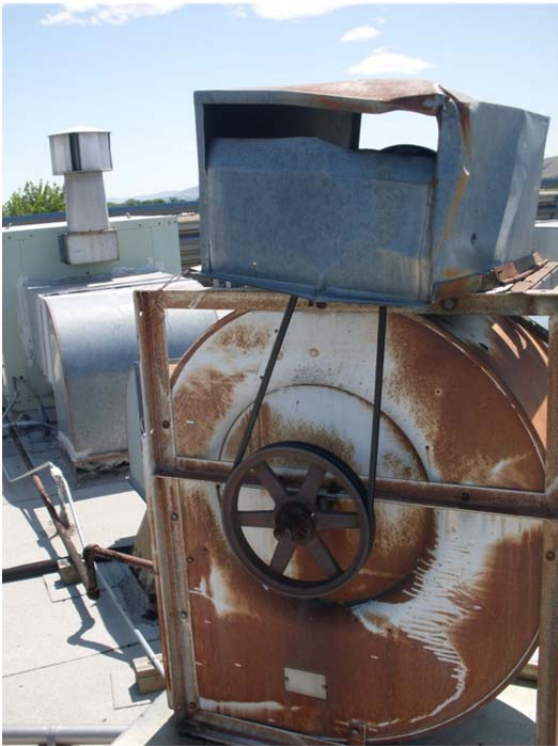
M-21: Abandoned swamp cooler fan

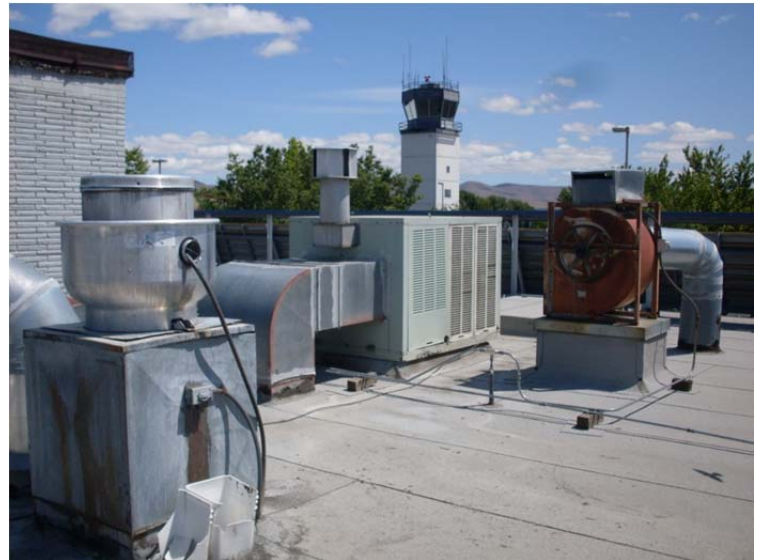
M-22: Kitchen grease hood exhaust fan

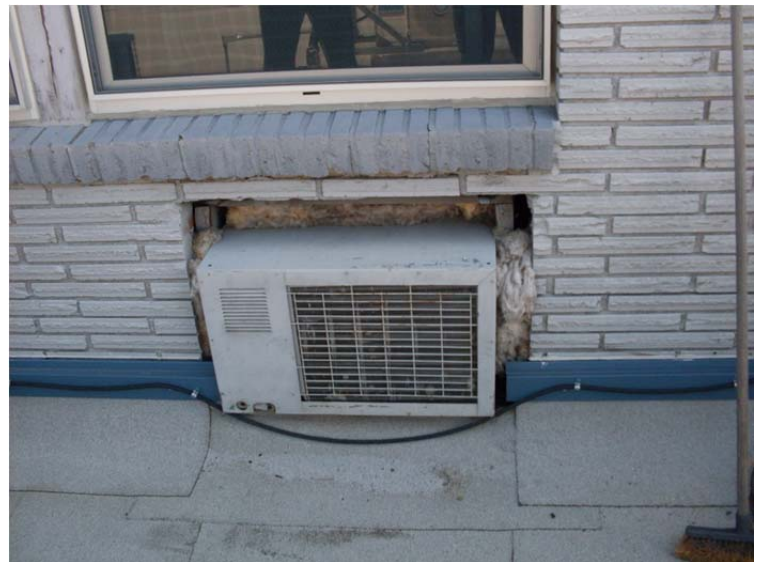
M-25: Through-wall AC unit

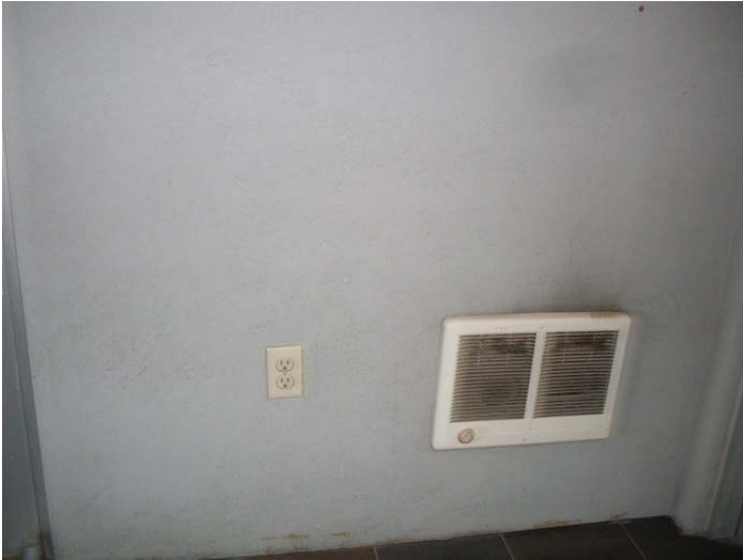
M-26: Typical wall heater

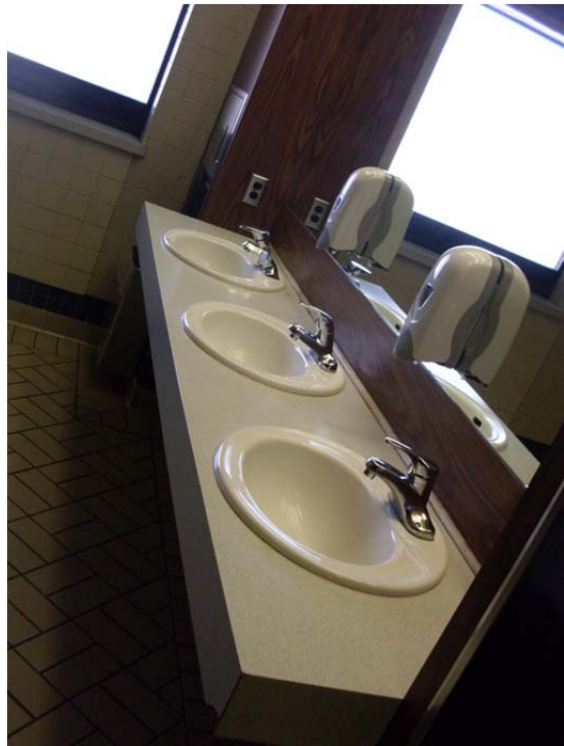
M-27: Renovated self-rimming lavatories/mixing faucet

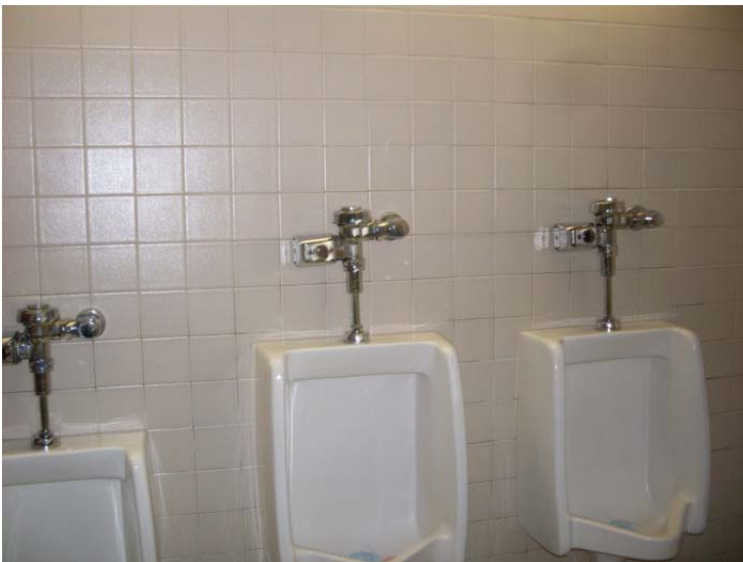
M-28: Flush valve urinals – one at ADA height

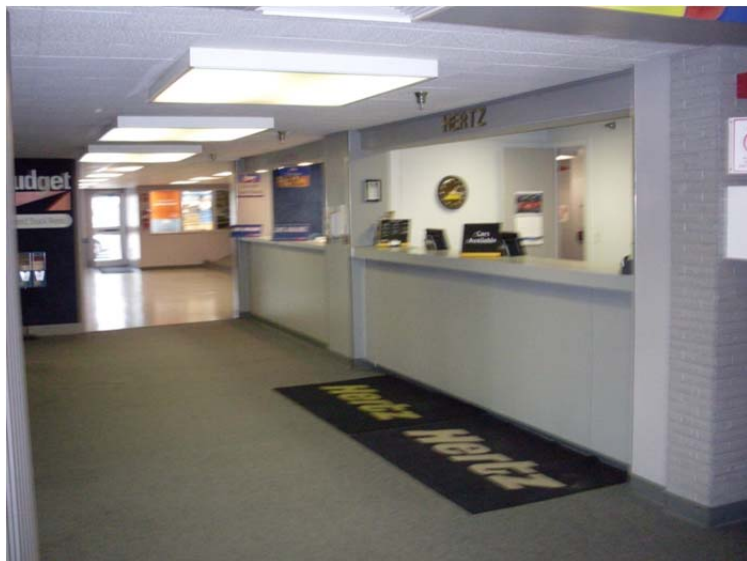
Heads within the terminal are a mixture of semi-recessed and exposed of varying vintages (picture M-30 and M-49). Heads generally are in good condition but appear to have lower hazard spacing than required by NFPA in the wood-framed building areas. External canopies and overhangs are generally served by dry sidewall heads from the wet fire sprinkler system.

M-30: Exposed fire sprinkler head

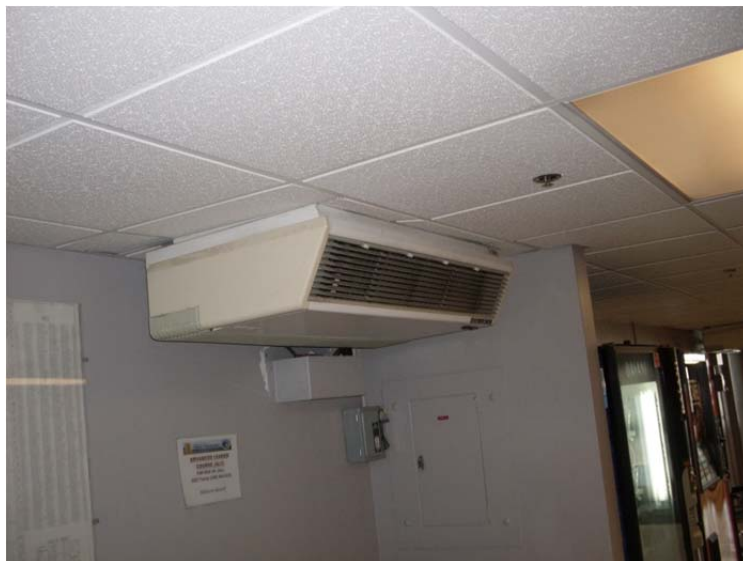
M-31: Semi-recessed fire sprinkler head

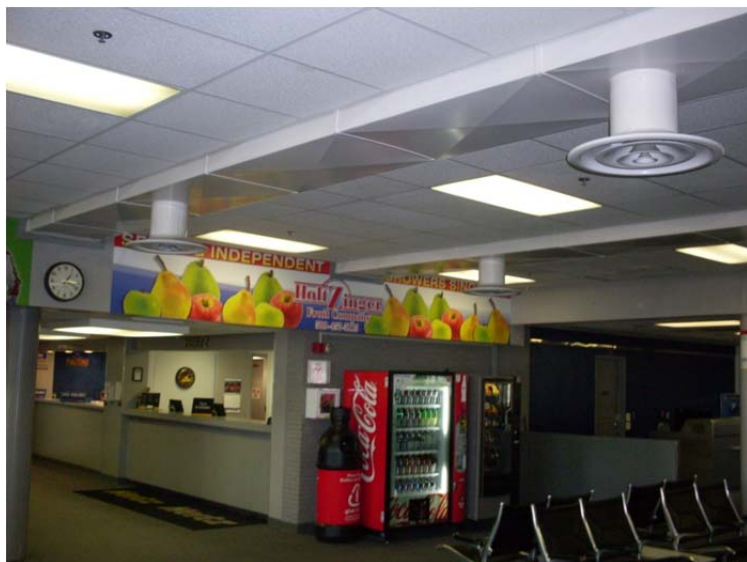
M-32: Ductwork below ceiling

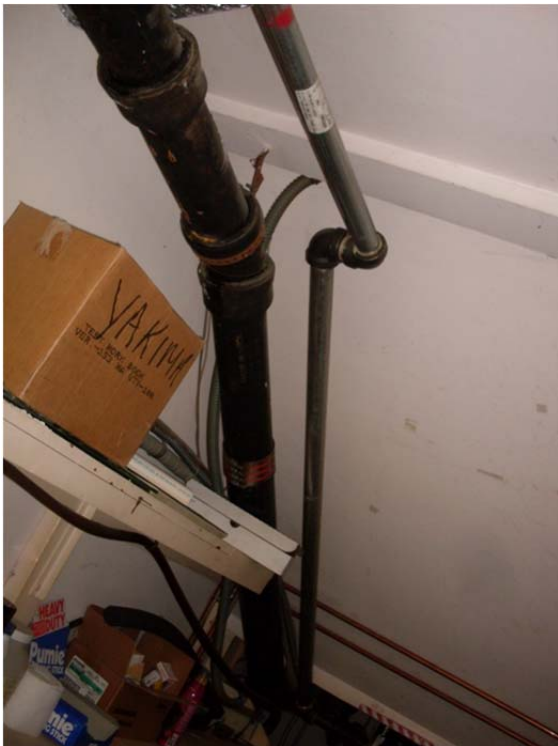
M-37: Plastic waste and vent piping repairs

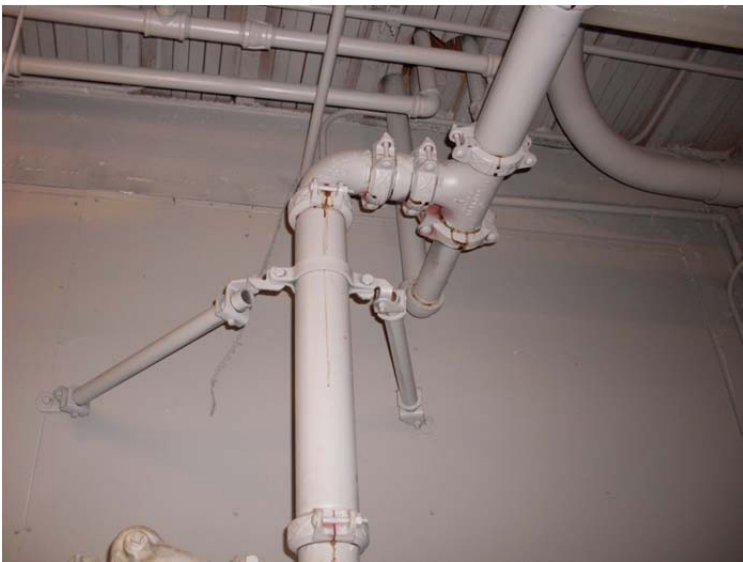
M-41: Fire sprinkler service entrance transition

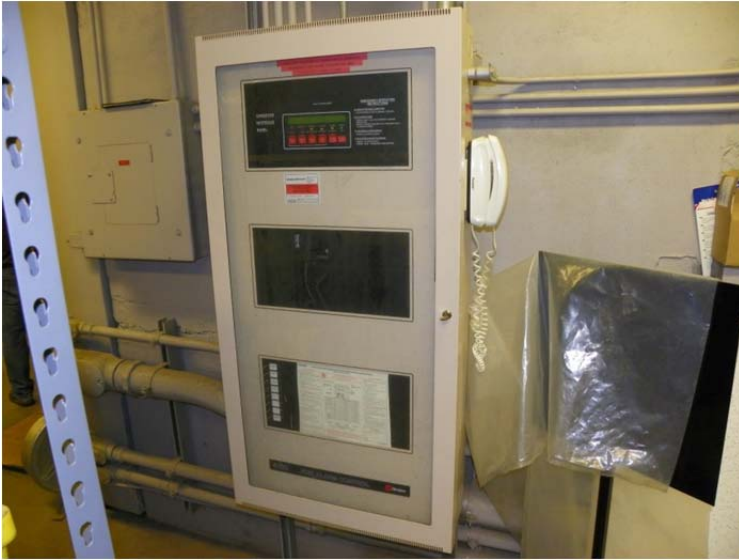
The existing fire alarm system is an addressable Simplex Grinnell 4100 fire alarm system. Pull stations are located at the exits and speaker/strobes are located throughout the building. The fire alarm system appears to be in good condition.

E-5: Fire alarm panel

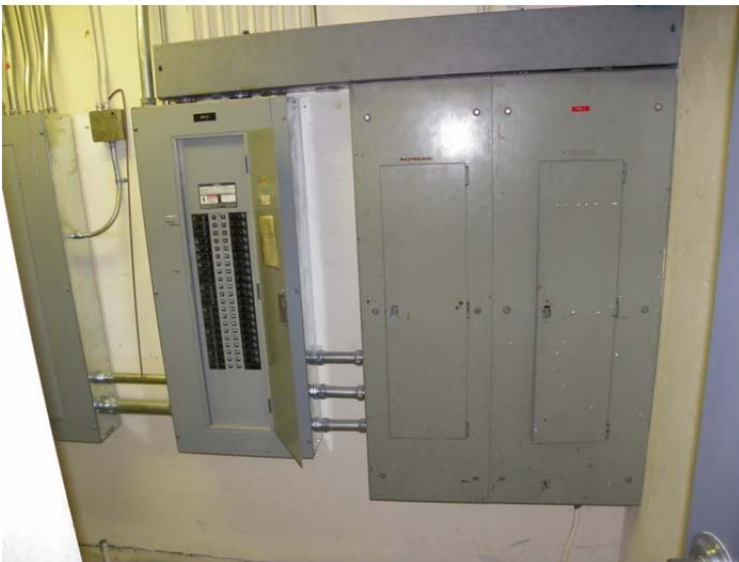
All of the panelboards throughout the building were replaced in 2000. Older panels were abandoned in place most with the interiors removed. Some panels are located in outdoor enclosures on the roof, which is not ideal. The panels appeared to be in good to fair condition. Many of the feeder conduits are routed exposed on the roof supported on wooden blocks.

E-7: New and abandoned panels
